**Title:** Miller MightyLite Leading Edge Self Retracting Lifelines

**Issue:** **INTERNAL RECALL:** Potential defect with SRLs could lead to unprotected fall from heights

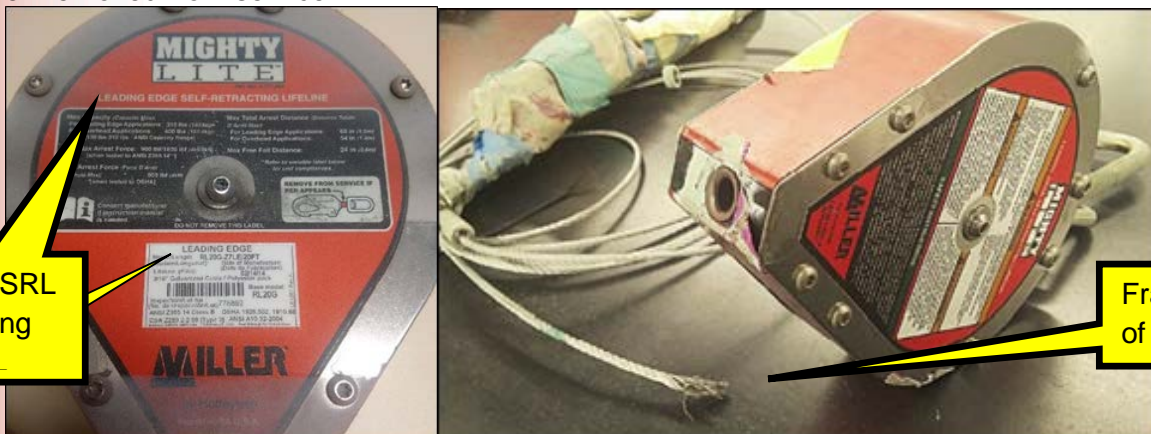
**Summary:** During routine inspections of Miller MightyLite Leading Edge Self Retracting Lifelines (SRLs) at an offsite decorative paint facility, the wire rope broke free from the SRL housing and fell to the floor. During the investigation, it was found that the rope had become frayed inside the housing to the extent that it broke loose. End users cannot inspect this portion of the wire rope. A detailed inspection of other MightyLite Leading Edge SRLs at the site found that 9 of 21 units were not in satisfactory condition and have been removed from service.

Indicates SRL is a Leading Edge SRL

Fraying at the end of wire rope

1. Immediately remove all Miller MightyLite Leading Edge SRLs from service. Replace with appropriate substitute SRL – see your EHS support for guidance. Immediately
2. Hold the Miller MightyLite SRLs pending completion of investigation and further instructions from Fall Protection PMT. The FP PMT will temporarily remove these SRL from the QPL and determine the next steps. - Immediately
